FIELD TEST WALL TECHNOLOGIES

SUPA PANEL

APARTMENT WALL SYSTEM 1B – WIDTH 189 mm

WALL SYSTEM TESTING

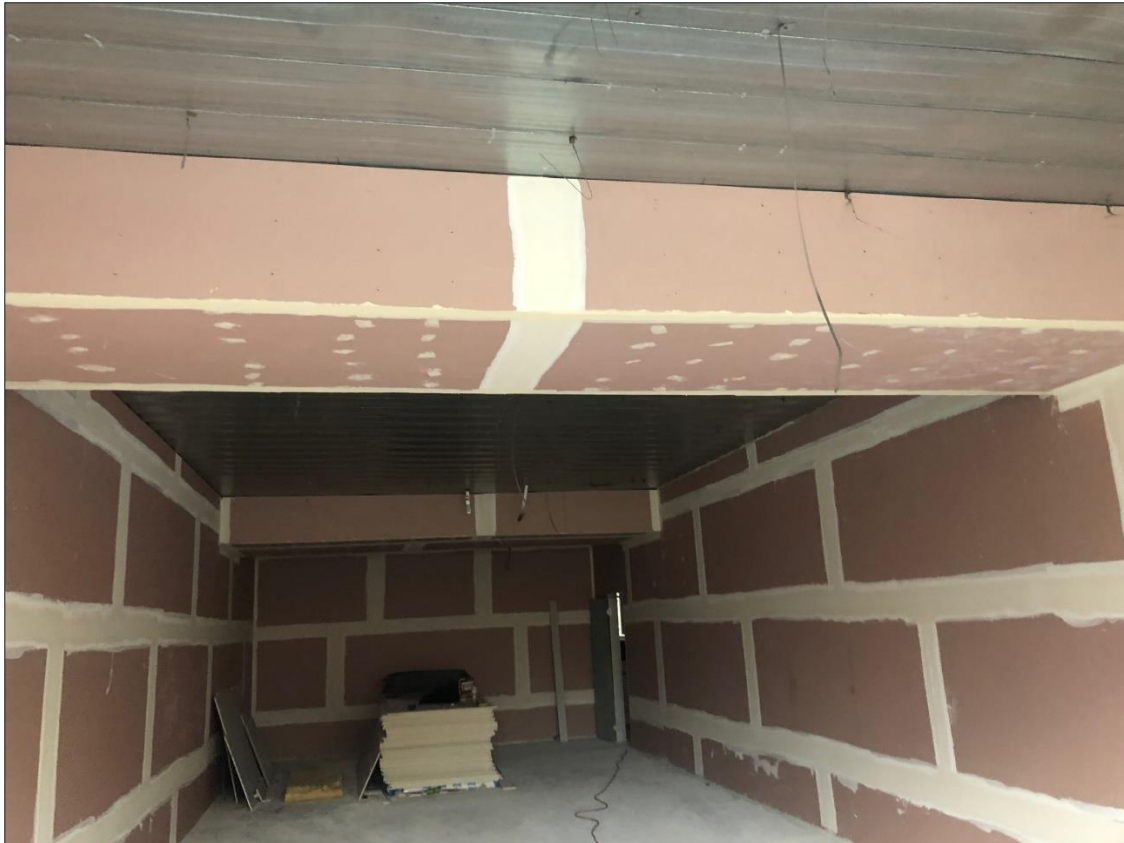
Figure 1: Bounding walls

The test facility consists of a large rectangular space within an existing office/warehouse space. The room has been constructed with bounding walls consisting of two layers of 13mm fire-rated plasterboard each side of steel studs. Services ductwork has also been clad as shown in Figure 1.

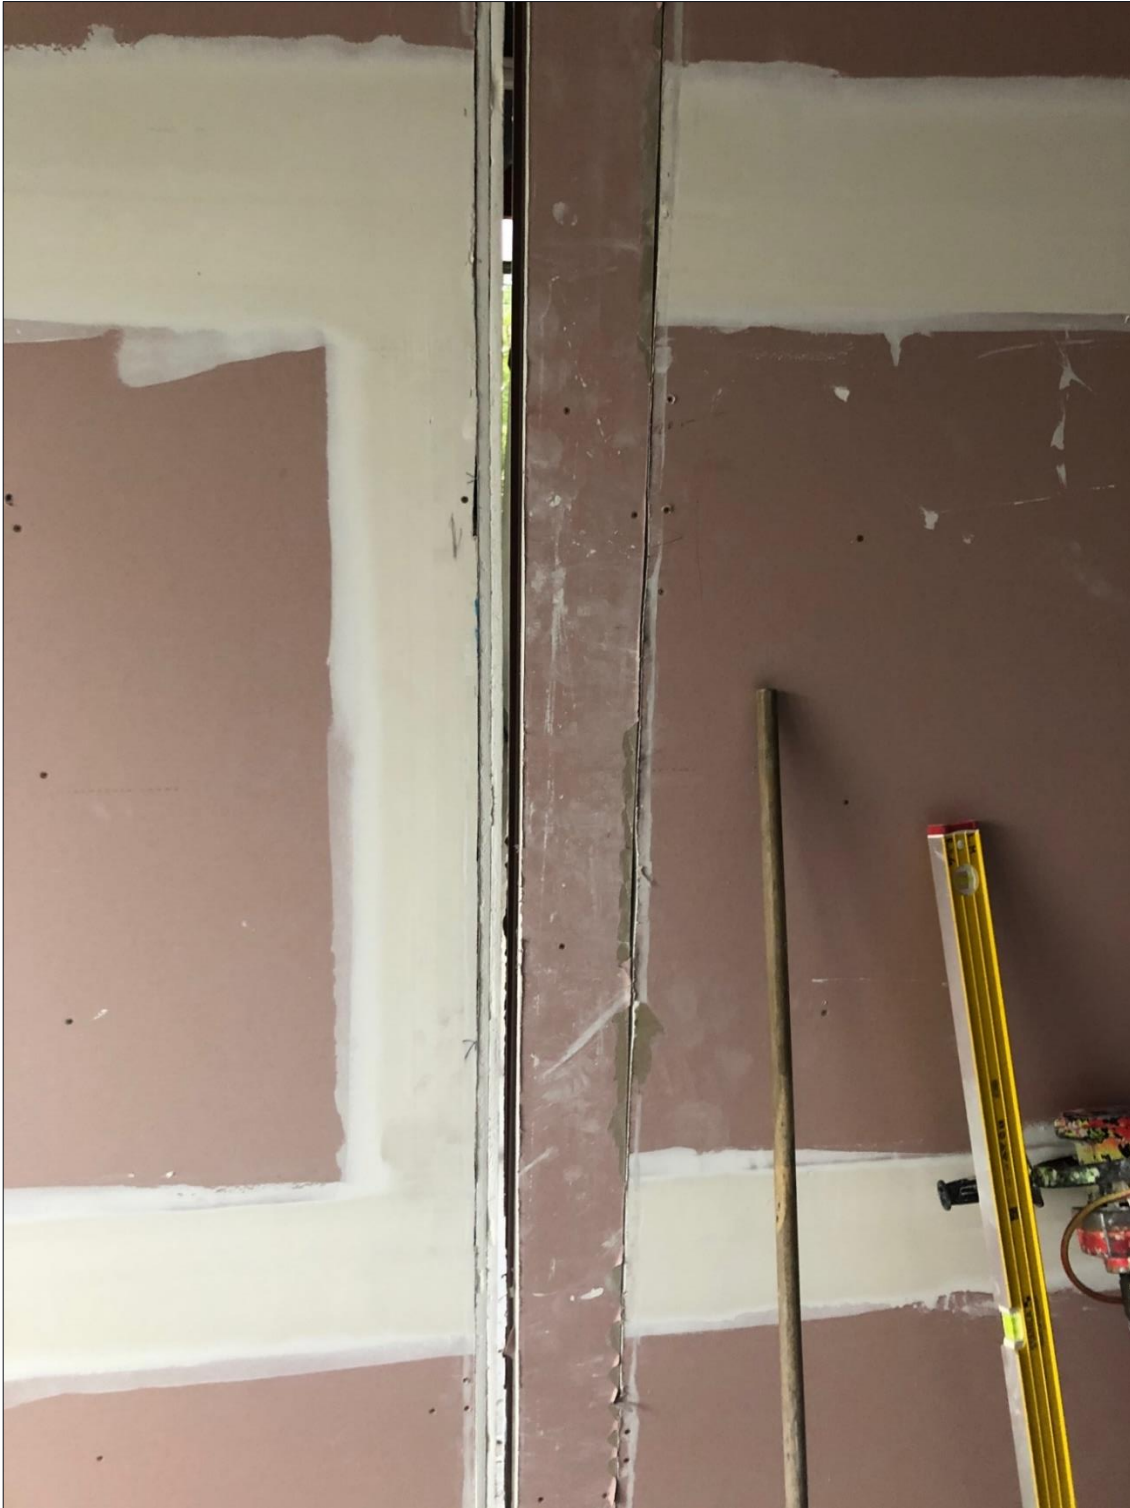
Figure 2: Structural break in bounding wall

The test sample is to be mounted at a dedicated location to divide space into two separate rooms. The sample location includes a structural break to limit sound flanking via the bounding walls. The structural break is shown in Figure 2. The break has subsequently been packed with rubber.

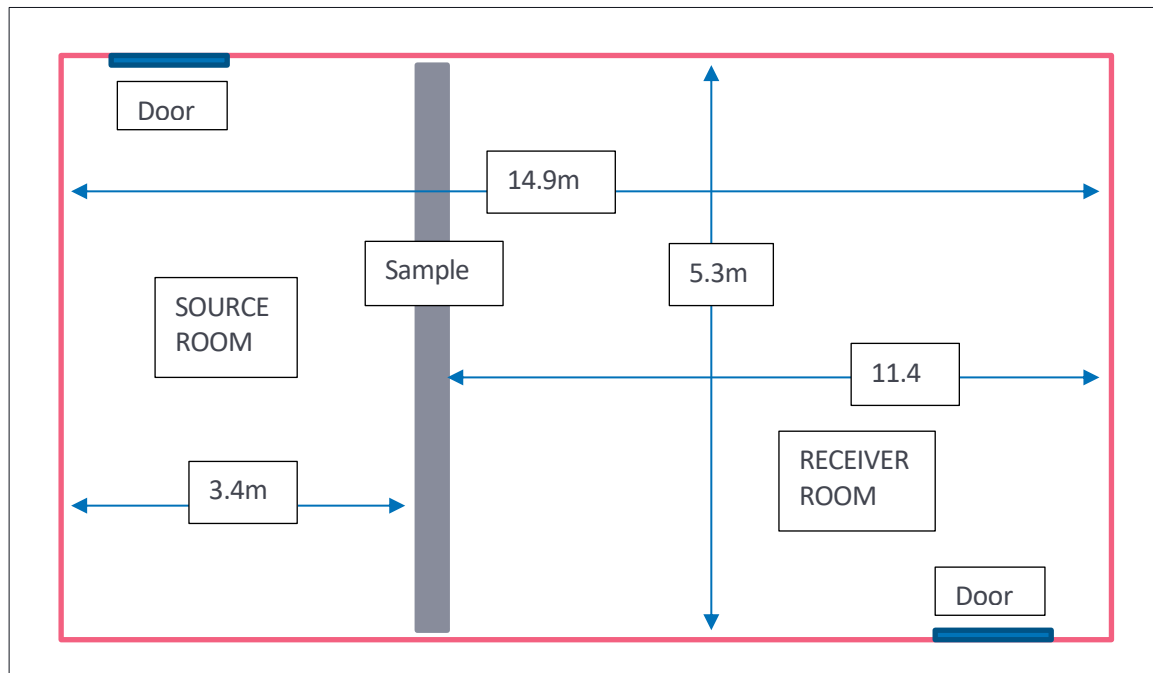
Figure 3: Room dimensions

With the test sample installed, the space is divided into two separate spaces with dimensions as shown in Figure 3.

The Bondek slab above the space is at a height of 3.35m. An acoustic tile ceiling has been installed in the receiving room at a height of 3m with a 300mm wide margin around the perimeter and at bulkheads.

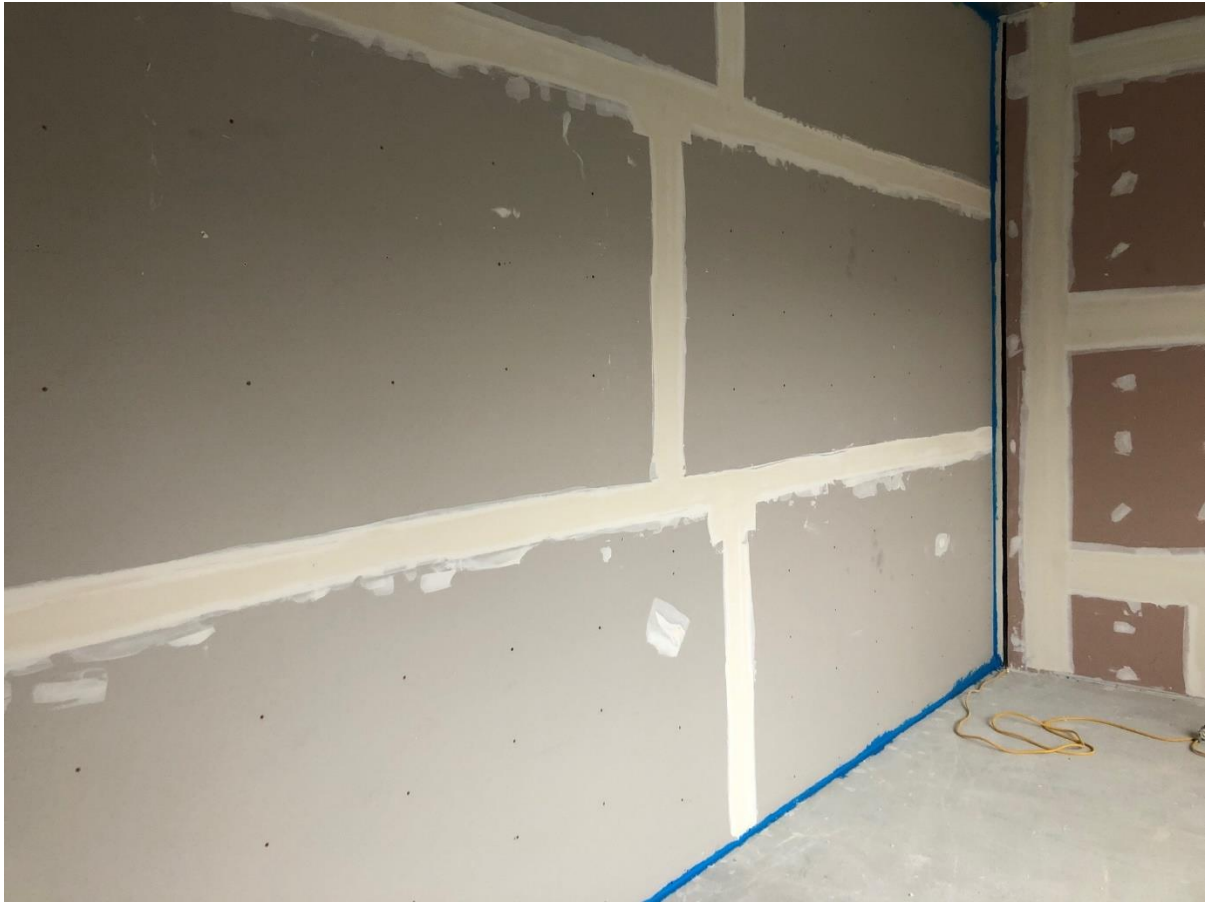
Figure 4: Source room side of wall

The panel can be described as a steel encased, aerated concrete panel system with a proprietary joint detail. The wall panel was mounted within steel tracks top and bottom and abutted the bounding walls on one side of the structural break only.

The wall panel had been installed in accordance with a typical installation detail for a riser shaft, i.e. all caulking and sealing was completed from one side only, in this case the source room side. The lining on battens was mounted on the source room side of the wall. The separate stud lining was mounted on the receiver room side.

The source room side of the wall is shown in Figure 4.

- 13 mm Knauf RE board (650 kg/m³ density) (receiver side)
- 51 mm steel stud
- 75 mm thick, 14 kg/m³ Bradford glasswool insulation
- 20 mm clear gap
- 64 mm thick panel (380 kg/m³ density ; 0.35 mm thick steel skins)
- 16 mm steel batten & clip to create 28mm air-gap (no cavity insulation)
- 13 mm Knauf RE board (650 kg/m³ density) (source side)

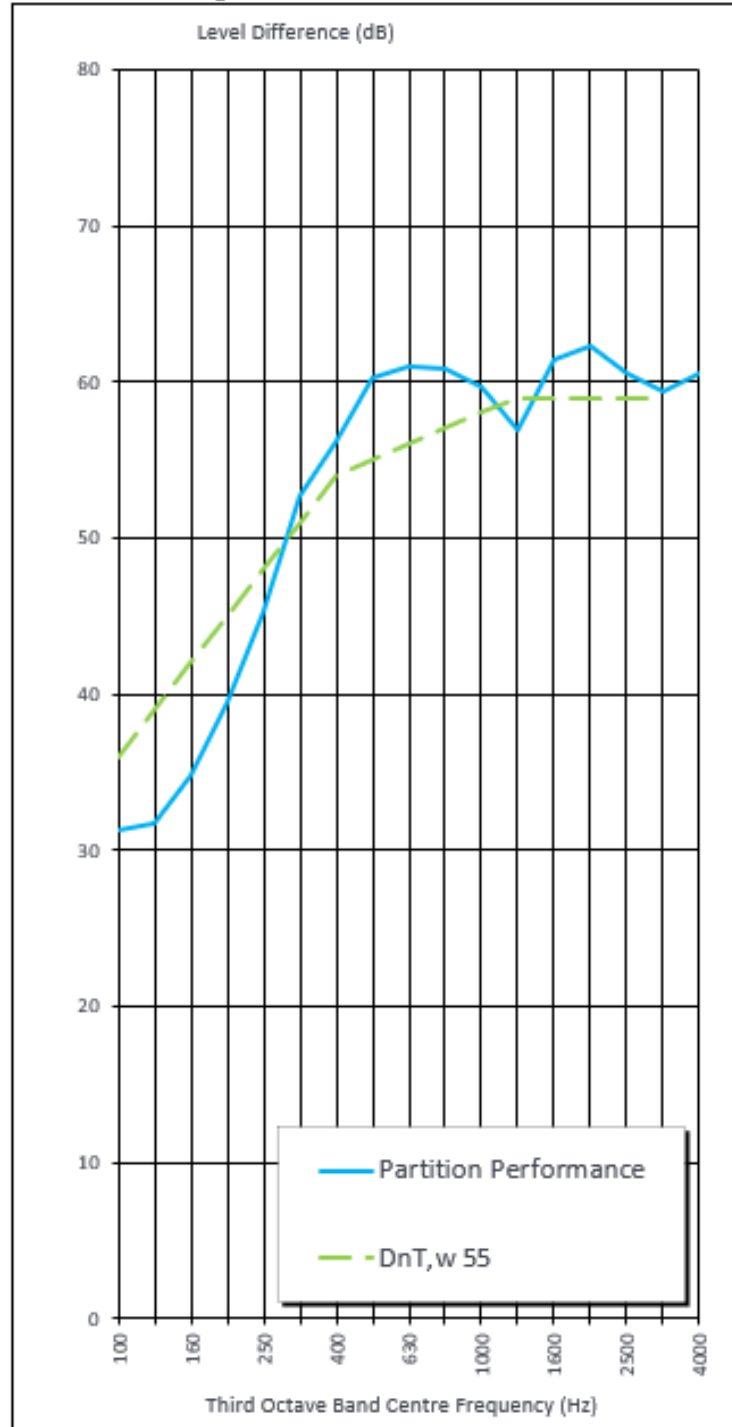
Figure 5: Sound Insulation Test Results

The sample was tested on 25 March 2020. The test result is provided in Figure 5.

System: APARTMENT WALL SYSTEM 1B - 13mm Knauf RE board + 16mm batten + clip for 28gap + no insul + 64mm wall + 20mm gap + 51mm stud + 75/14 Bradford gw + 13mm Knauf RE board

| DnT,w | 55 |
| $C_{100-3150}$ | -3 |
| $C_{tr,100-3150}$ | -9 |

It was noted that some high frequency sound leakage was apparent at some of the poorly aligned panel junctions which resulted in a deficiency of 2dB compared to well aligned junctions.
