FIELD TEST WALL TECHNOLOGIES

SUPA PANEL

SHAFT WALL SYSTEM 2A – WIDTH 105 mm

WALL SYSTEM TESTING

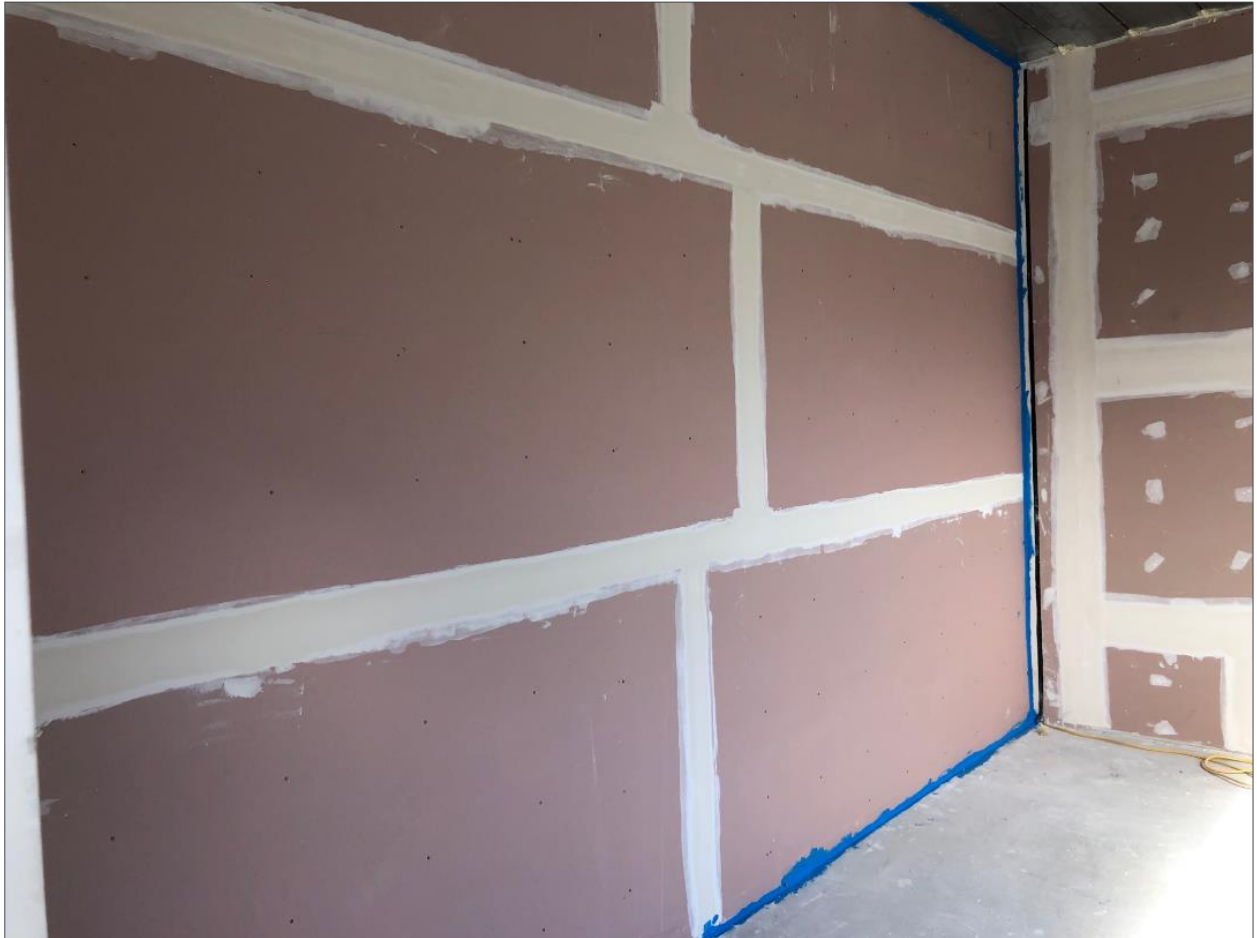
Figure 4: Source room side of wall

The source room side of the wall is shown in Figure 4.

- 64 mm thick panel (380 kg/m³ density ; 0.35 mm thick steel skins)
- 16 mm batten & clip for 28 mm air-gap
- 25 mm thick 18 kg/m³ Bradford insulation (in 28 mm gap)
- 13 mm Knauf Fireshield (800 kg/m³ density) (source side)

The panel can be described as a steel encased, aerated concrete panel system with a proprietary joint detail. The wall panel was mounted within steel tracks top and bottom and abutted the bounding walls on one side of the structural break only.

The wall panel had been installed in accordance with a typical installation detail for a riser shaft, i.e. all caulking and sealing was completed from one side only, in this case the source room side.
