## **FIELD TEST WALL TECHNOLOGIES**

### **SUPA PANEL**

### **APARTMENT WALL SYSTEM 2A – WIDTH 189 mm**

## **WALL SYSTEM TESTING**

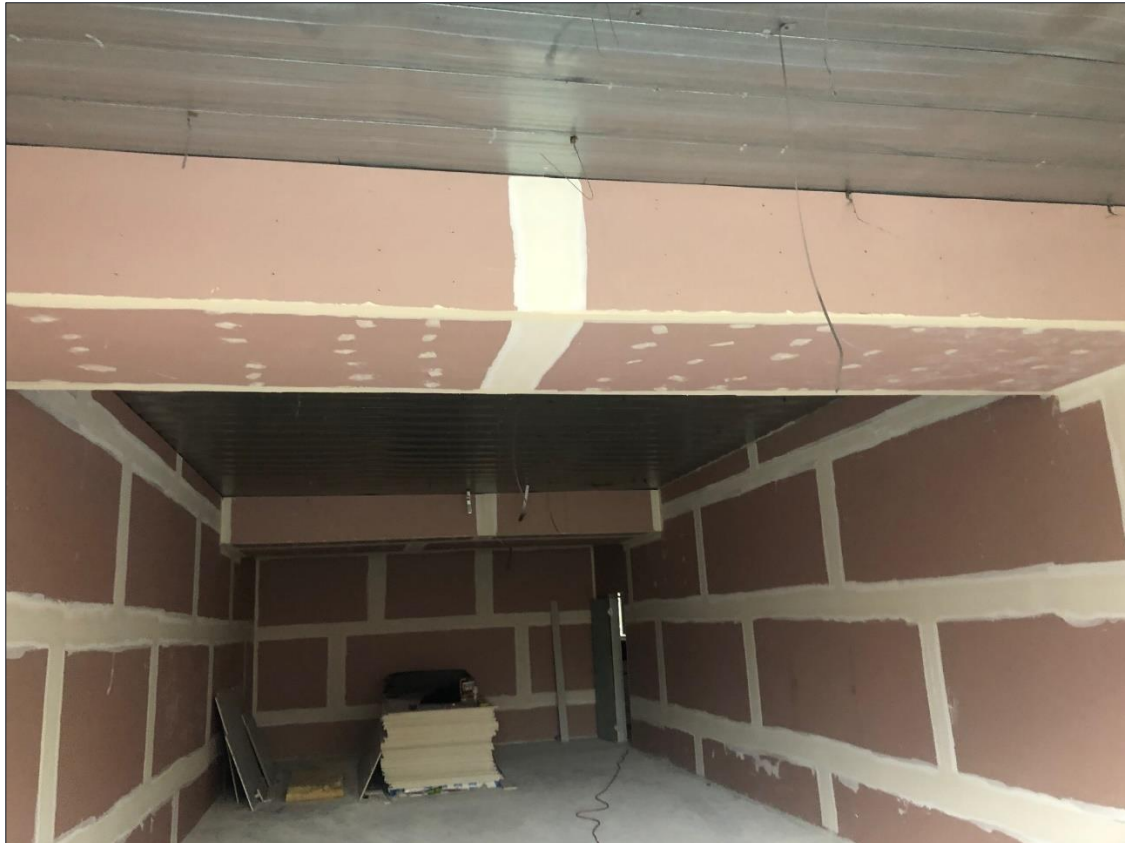
**Figure 1: Bounding walls**

The test facility consists of a large rectangular space within an existing office/warehouse space. The room has been constructed with bounding walls consisting of two layers of 13mm fire-rated plasterboard each side of steel studs. Services ductwork has also been clad as shown in Figure 1.

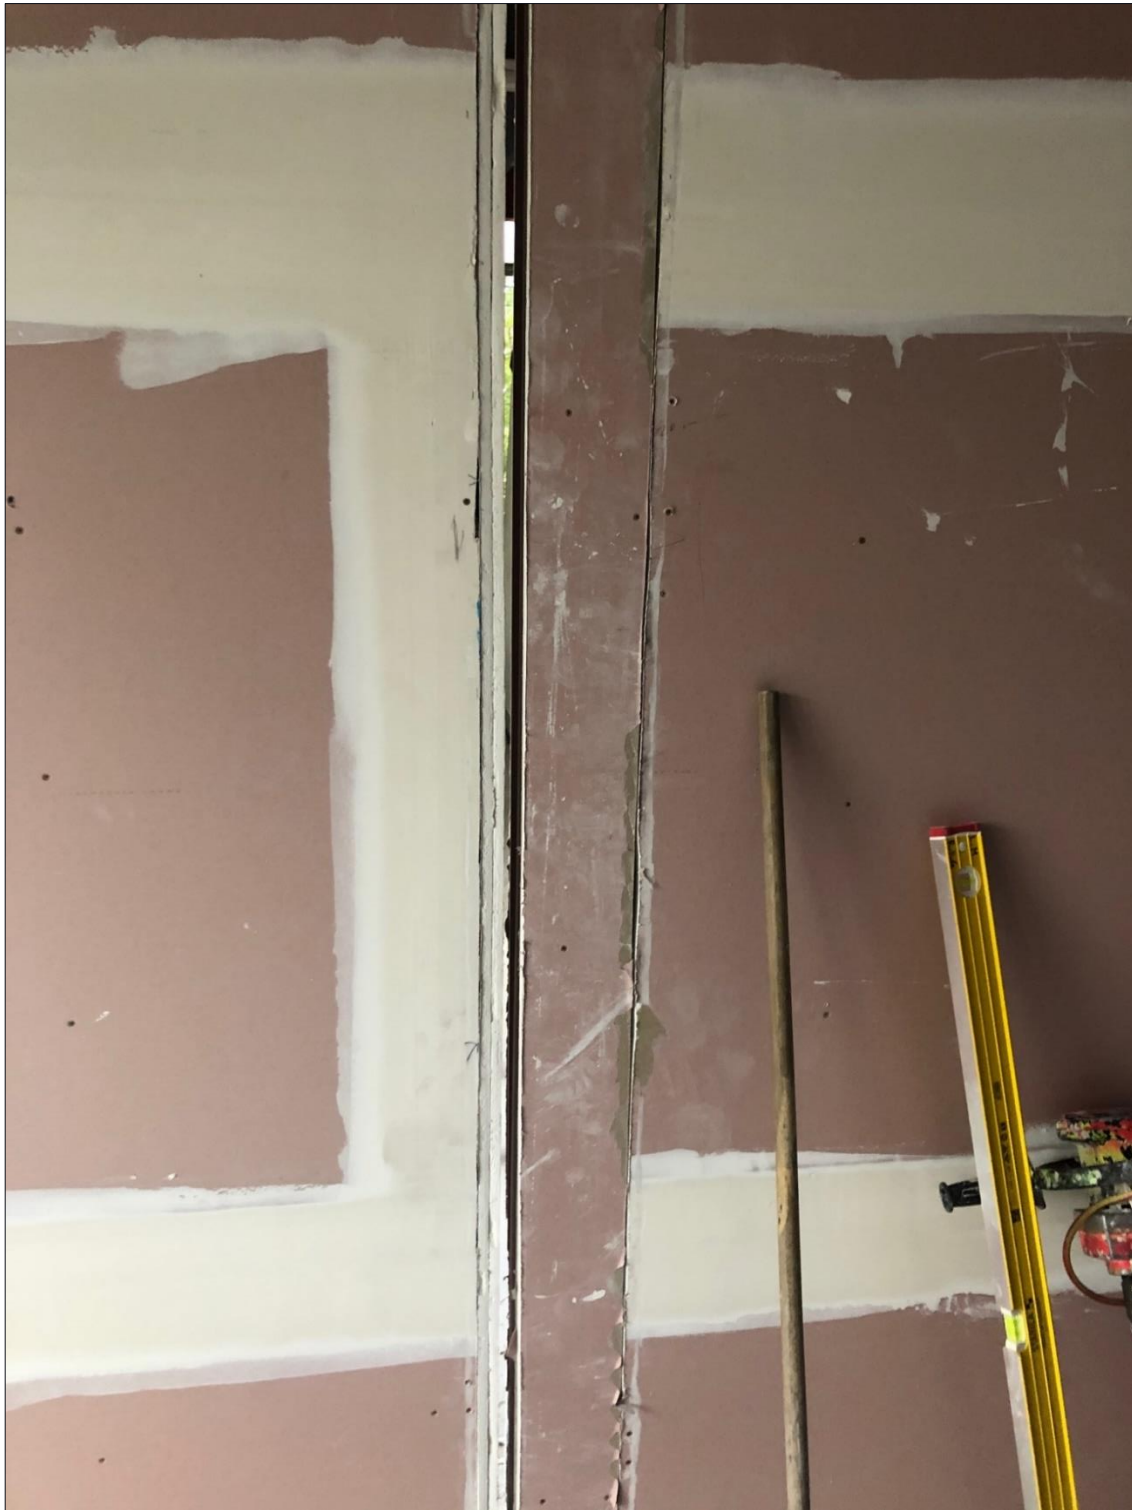
Figure 2: Structural break in bounding wall

The test sample is to be mounted at a dedicated location to divide space into two separate rooms. The sample location includes a structural break to limit sound flanking via the bounding walls. The structural break is shown in Figure 2. The break has subsequently been packed with rubber.

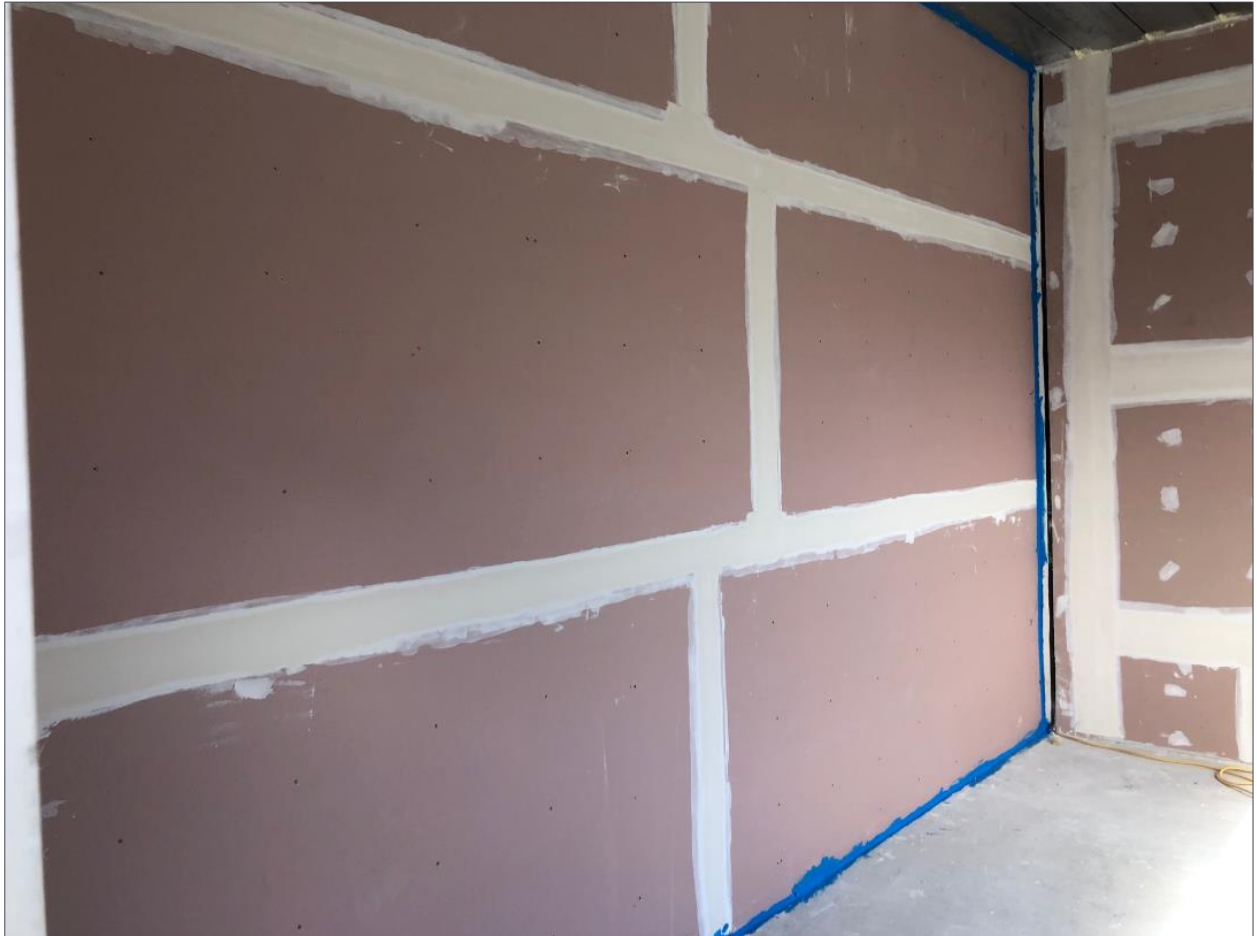
Figure 4: Source room side of wall

The panel can be described as a steel encased, aerated concrete panel system with a proprietary joint detail. The wall panel was mounted within steel tracks top and bottom and abutted the bounding walls on one side of the structural break only.

The wall panel had been installed in accordance with a typical installation detail for a riser shaft, i.e. all caulking and sealing was completed from one side only, in this case the source room side. The separate stud lining was mounted on the receiver room side.

The source room side of the wall is shown in Figure 4.

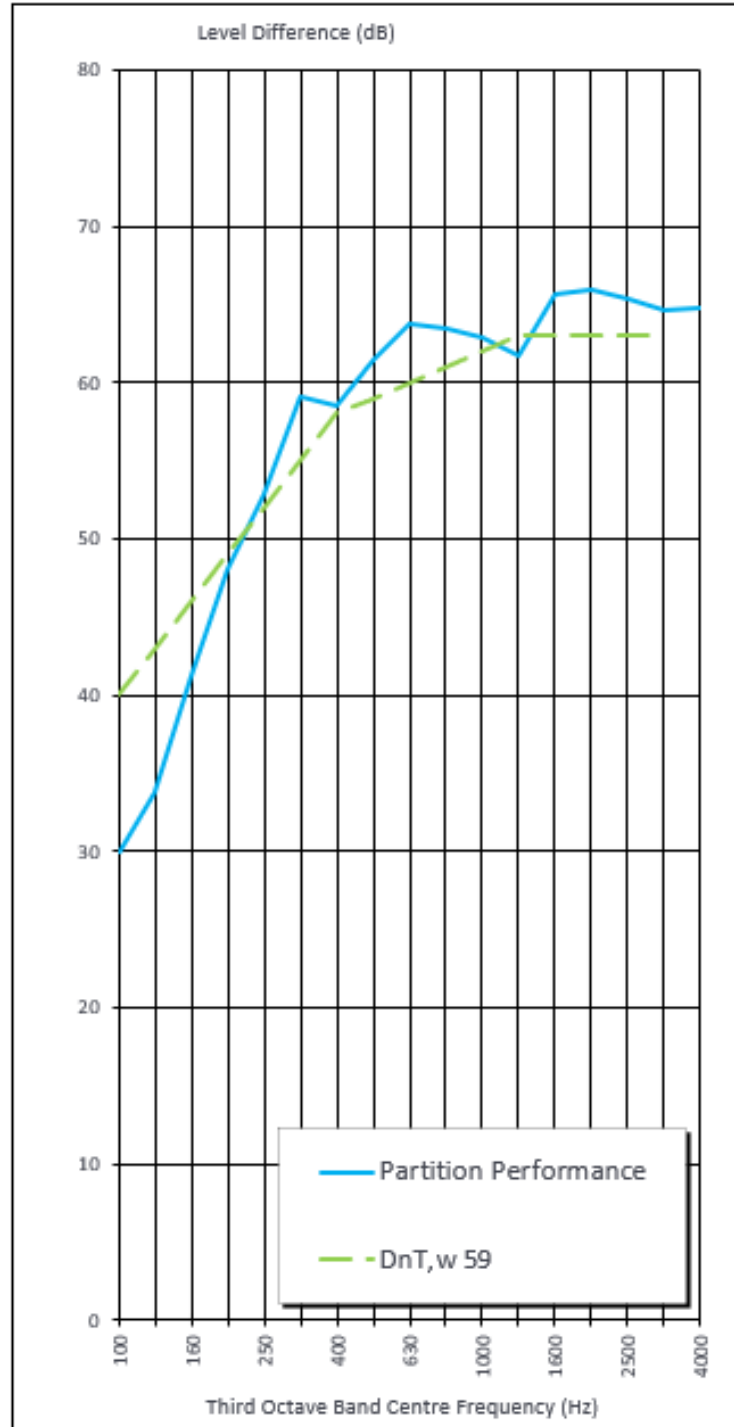
Figure 5: Sound Insulation Test Results:

The sample was tested on 30 March 2020. The test result is provided in Figure 5.

**System:** APARTMENT WALL SYSTEM 2A - 13mm Knauf Fireshield + 28mm gap + 25/18 Bradford ins + 64mm wall + 20mm gap + 51mm stud + 75/14 Bradford gw + 13mm Knauf RE board

Frequency (Hz)	DnT* (dB)	Adverse Deviation (dB)	Receiving RT (s)
50			
63			
80			
100	29.9	10.1	0.8
125	33.8	9.2	0.7
160	41.1	4.9	0.7
200	48.0	1.0	0.5
250	52.8		0.6
315	59.1		0.6
400	58.4		0.5
500	61.5		0.4
630	63.8		0.4
800	63.5		0.4
1000	62.9		0.4
1250	61.7	1.3	0.4
1600	65.7		0.5
2000	66.0		0.5
2500	65.3		0.4
3150	64.6		0.4
4000	64.7	-	0.4
Sum of Adverse Deviations			26.5

<b>DnT<sub>w</sub></b>	59
C <sub>100-3150</sub>	-4
C <sub>tr,100-3150</sub>	-11
