FIELD TEST WALL TECHNOLOGIES

SUPA PANEL

SHAFT WALL SYSTEM 2B - WIDTH 118 mm

WALL SYSTEM TESTING

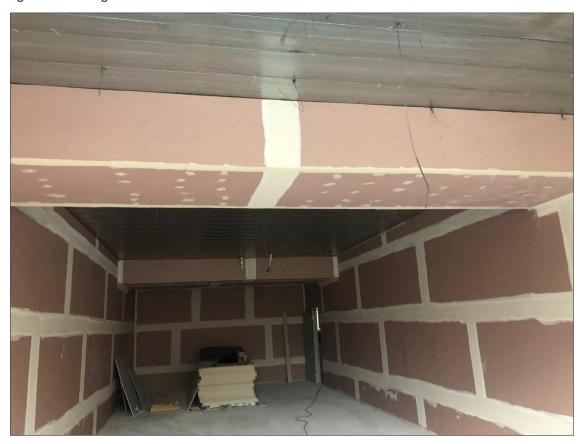
The test facility consists of a large rectangular space within an existing office/warehouse space. The room has been constructed with bounding walls consisting of two layers of 13mm fire-rated plasterboard each side of steel studs. Services ductwork has also been clad as shown in Figure 1.

Figure 1: Bounding walls

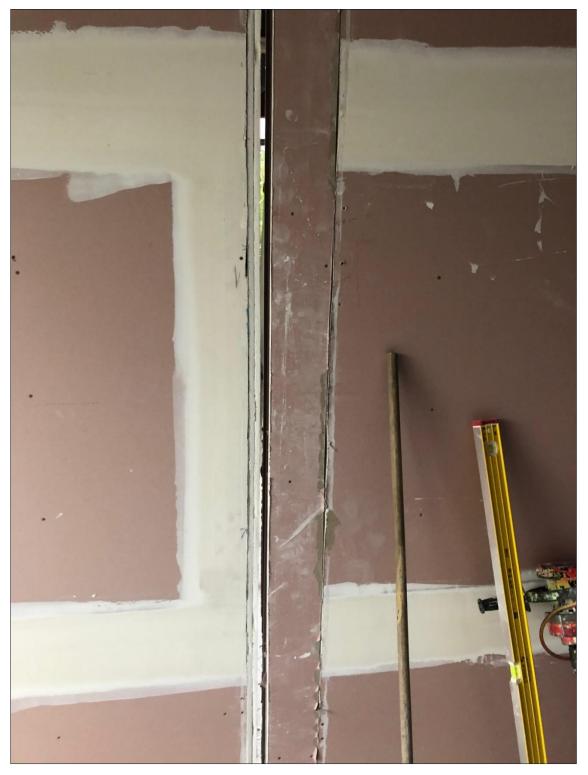
The test sample is to be mounted at a dedicated location to divide space into two separate rooms. The sample location includes a structural break to limit sound flanking via the bounding walls. The structural break is shown in Figure 2. The break has subsequently been packed with rubber.

Figure 2: Structural break in bounding wall

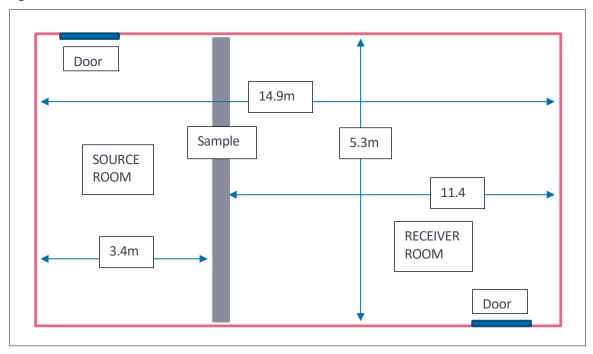
With the test sample installed, the space is divided into two separate spaces with dimensions as shown in Figure 3.

Figure 3: Room dimensions

The Bondek slab above the space is at a height of 3.35m. An acoustic tile ceiling has been installed in the receiving room at a height of 3m with a 300mm wide margin around the perimeter and at bulkheads.

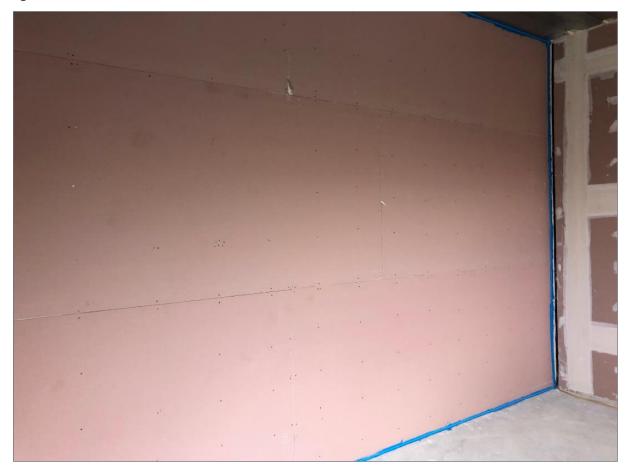
The source room side of the wall is shown in Figure 4.

Figure 4: Source room side of wall

- 64 mm thick panel (380 kg/m³ density; 0.35 mm thick steel skins)
- 16 mm batten & clip for 28 mm air-gap
- 25 mm thick 18 kg/m³ Bradford insulation (in 28 mm gap)
- 2 x 13 mm Knauf Fireshield (800 kg/m³ density) (source side)

The panel can be described as a steel encased, aerated concrete panel system with a proprietary joint detail. The wall panel was mounted within steel tracks top and bottom and abutted the bounding walls on one side of the structural break only.

The double wall panel had been installed in accordance with a typical installation detail for a riser shaft, i.e. all caulking and sealing was completed from one side only, in this case the source room side.

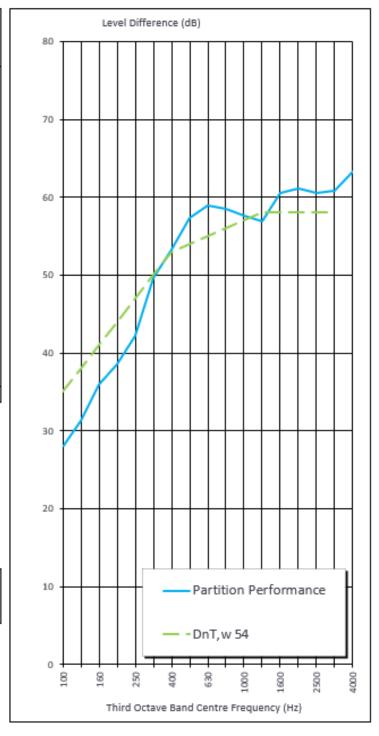
Figure 5: Sound Insulation Test Results:

System: SHAFT WALL SYSTEM 2B - 2 x 13mm Knauf Fireshield + 28mm gap + 25/18 Bradford ins + 64mm wall

Frequency		Adverse	Receiving
	DnT.	Deviation	RT
(Hz)	(dB)	(dB)	(s)
50			
63			
80			
100	28.0	7.0	0.8
125	31.2	6.8	0.7
160	35.9	5.1	0.7
200	38.6	5.4	0.5
250	42.2	4.8	0.6
315	49.7	0.3	0.6
400	53.2		0.5
500	57.3		0.4
630	59.0		0.4
800	58.5		0.4
1000	57.6		0.4
1250	56.9	1.1	0.4
1600	60.5		0.5
2000	61.2		0.5
2500	60.5		0.4
3150	60.9		0.4
4000	63.3	-	0.4
Sum of Adverse Deviations			30.5

DnT,⊎	54
C,100-3150	-3
C _{tr,100-3150}	-9

The sample was tested on 31 March 2020. The test result is provided in Figure 5.
