FIELD TEST WALL TECHNOLOGIES

SUPA PANEL

SHAFT WALL SYSTEM 3A – WIDTH 148 mm

WALL SYSTEM TESTING

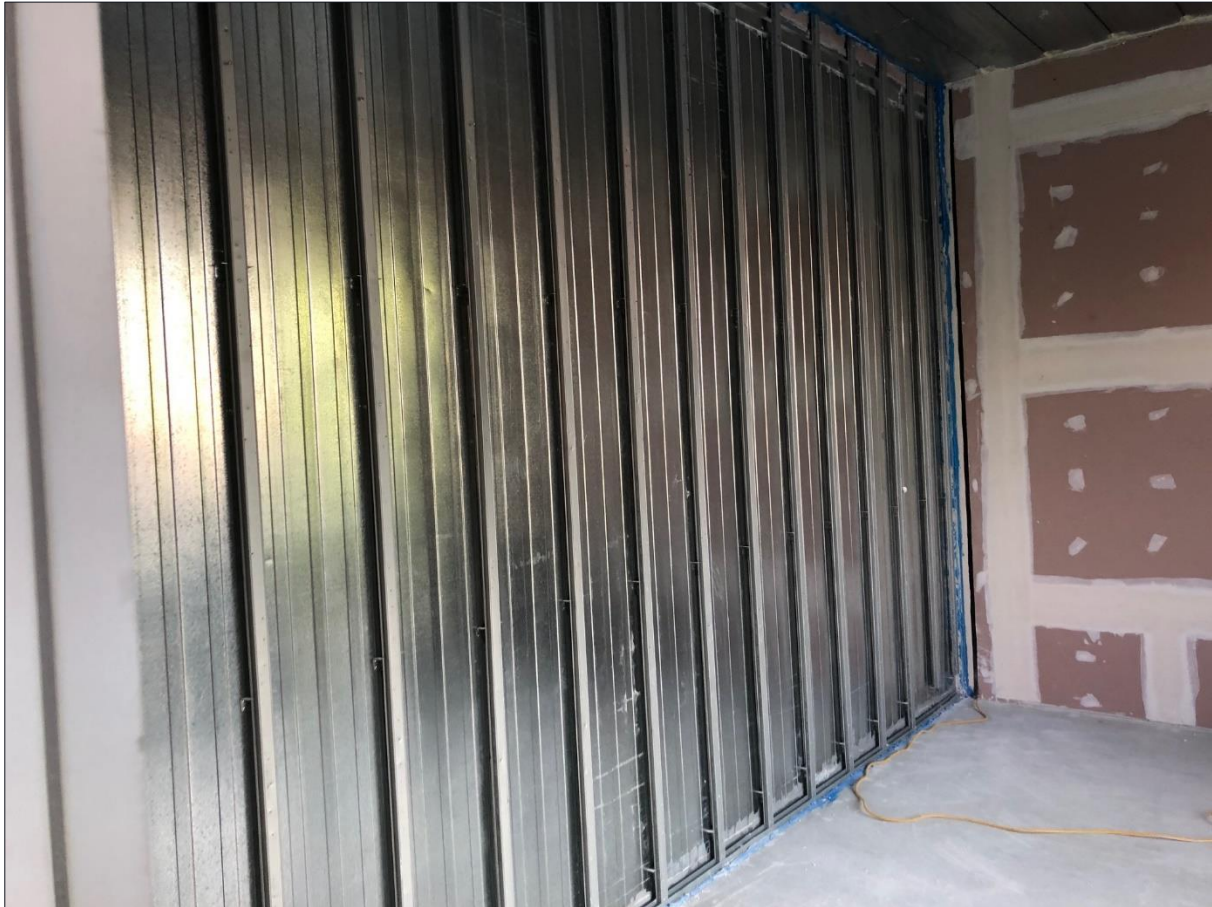
Figure 4: Source room side of wall

The panel can be described as a steel encased, aerated concrete panel system with a proprietary joint detail. The wall panel was mounted within steel tracks top and bottom and abutted the bounding walls on one side of the structural break only.

The wall panel had been installed in accordance with a typical installation detail for a riser shaft, i.e. all caulking and sealing was completed from one side only, in this case the source room side. The separate stud lining was mounted on the receiver room side.

The source room side of the wall is shown in Figure 4.

- 13 mm Knauf RE board (650 kg/m³ density) (receiver side)
- 51 mm steel stud
- 75 mm thick, 14 kg/m³ Bradford glasswool insulation
- 20 mm clear gap
- 64 mm thick panel (380 kg/m³ density ; 0.35 mm thick steel skins)
