## **FIELD TEST WALL TECHNOLOGIES**

### **SUPA PANEL**

**TEST DATE: 16 MARCH 2020**

## **WALL SYSTEM TESTING**

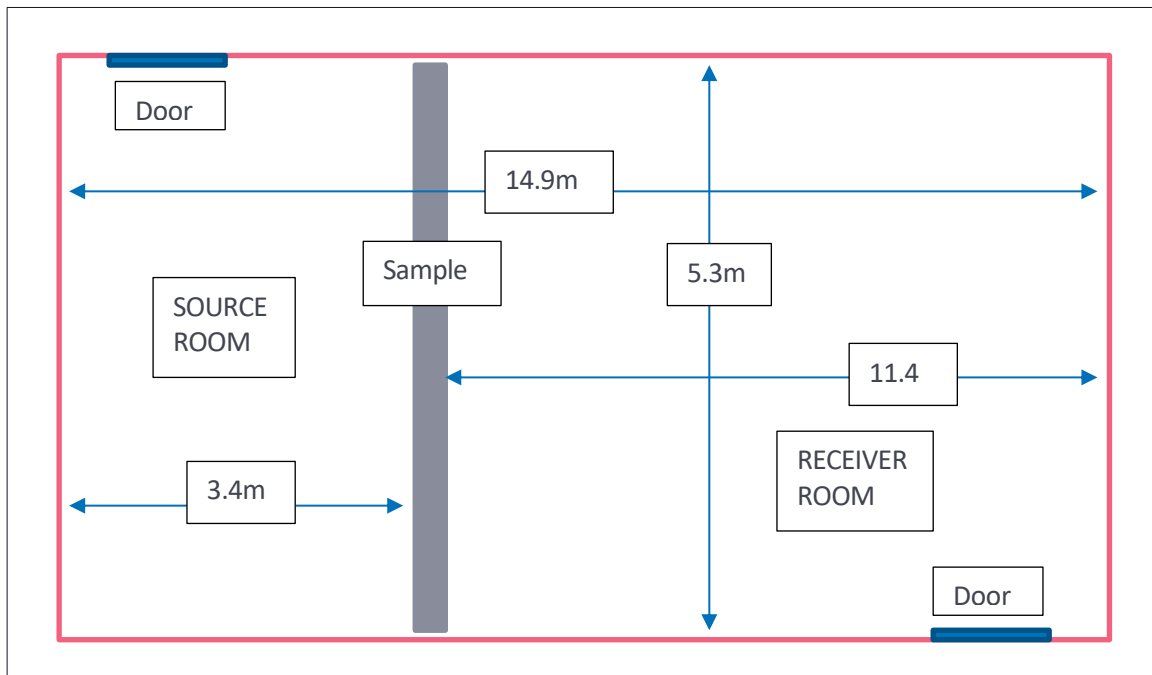
Figure 3: Room dimensions

With the test sample installed, the space is divided into two separate spaces with dimensions as shown in Figure 3.

The Bondek slab above the space is at a height of 3.35m. An acoustic tile ceiling has been installed in the receiving room at a height of 3m with a 300mm wide margin around the perimeter and at bulkheads.

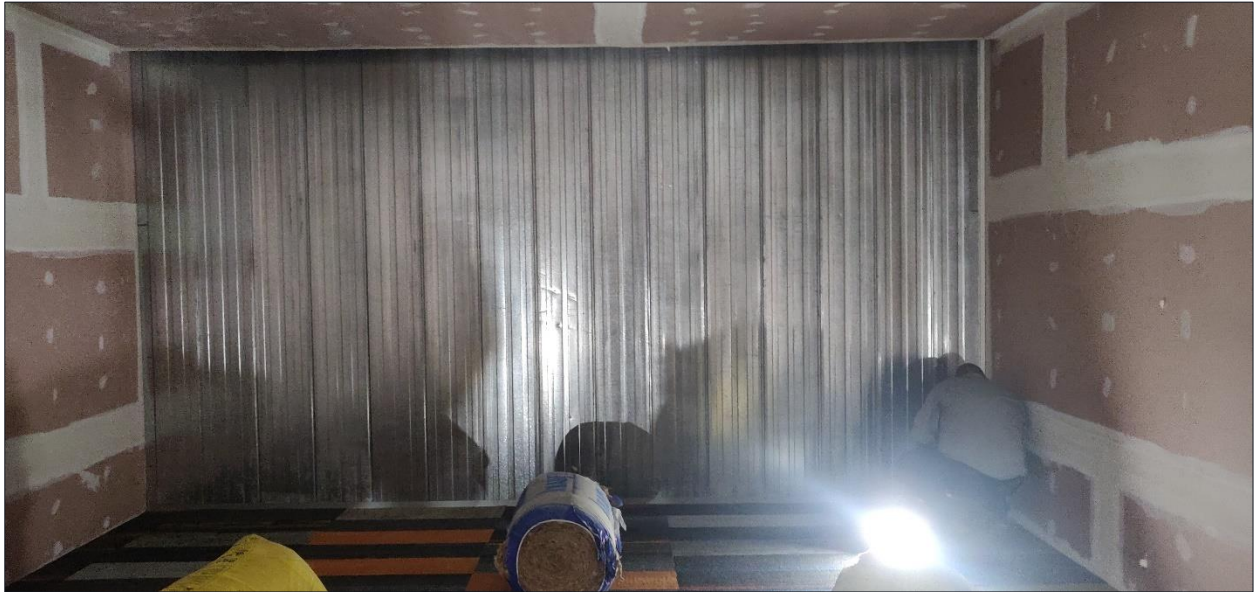
Figure 4: Wall panel system test sample

The wall panel test sample measured on 16 March 2020 is described as a steel encased, aerated concrete panel system with a proprietary joint detail. The panel had the following characteristics:

- 64mm thick
- 380kg/m<sup>3</sup> density
- 0.35mm thick steel skins

The wall panel was mounted within steel tracks top and bottom and abutted the bounding walls on one side of the structural break only.

The wall panel had been installed in accordance with a typical installation detail for a riser shaft, i.e. all caulking and sealing was completed from one side only, in this case the source room side.

The installation of the wall panel system is shown in Figure 4.

It was noted that some panel junctions were better than others, which was also apparent during the testing as detailed below.

It was noted that some high frequency sound leakage was apparent at some of the poorly aligned panel junctions which resulted in a deficiency of 2dB compared to well aligned junctions.

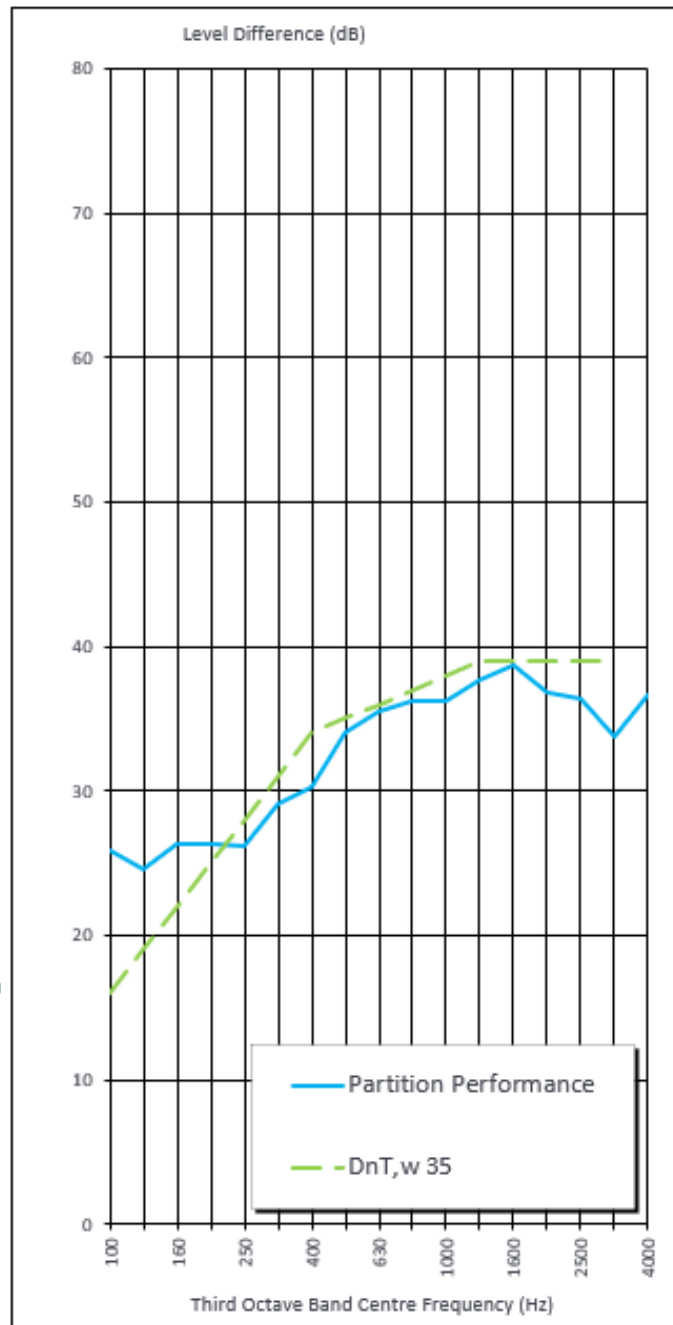
Figure 5: Test results

The sample was tested on 16 March 2020. The test result is provided in Figure 5.

**Job Title:** K8 Australia testing  
**Job No:** 20200246  
**Client:** K8 Australia  
**Test Date:** 16/03/2020  
**System:** Bare 64mm panel

Frequency (Hz)	DnT* (dB)	Adverse Deviation (dB)	Receiving RT (s)
50			
63			
80			
100	25.9		0.8
125	24.5		0.9
160	26.4		0.7
200	26.4		0.6
250	26.1	1.9	0.7
315	29.1	1.9	0.6
400	30.2	3.8	0.6
500	34.1	0.9	0.5
630	35.5	0.5	0.5
800	36.2	0.8	0.5
1000	36.2	1.8	0.5
1250	37.7	1.3	0.6
1600	38.8	0.2	0.7
2000	36.8	2.2	0.7
2500	36.4	2.6	0.9
3150	33.8	5.2	0.8
4000	36.7	-	0.9
Sum of Adverse Deviations			23.0

<b>DnT,w</b>	35
C <sub>r,100-3150</sub>	
C <sub>tr,100-3150</sub>	-2
